The Composition and Formation Mechanism of a Banded Scale in Clay Pipe Sewers

**David Jenkins
Professor Emeritus
Environmental Engineering
University of California
Berkeley**

**Prepared for
Mr. Joe Parker
National Clay Pipe Institute - Southern California
PO BOX 549, 23835 Temescal Canyon Rd.,
Corona, CA 91718, USA**

February 16, 2009

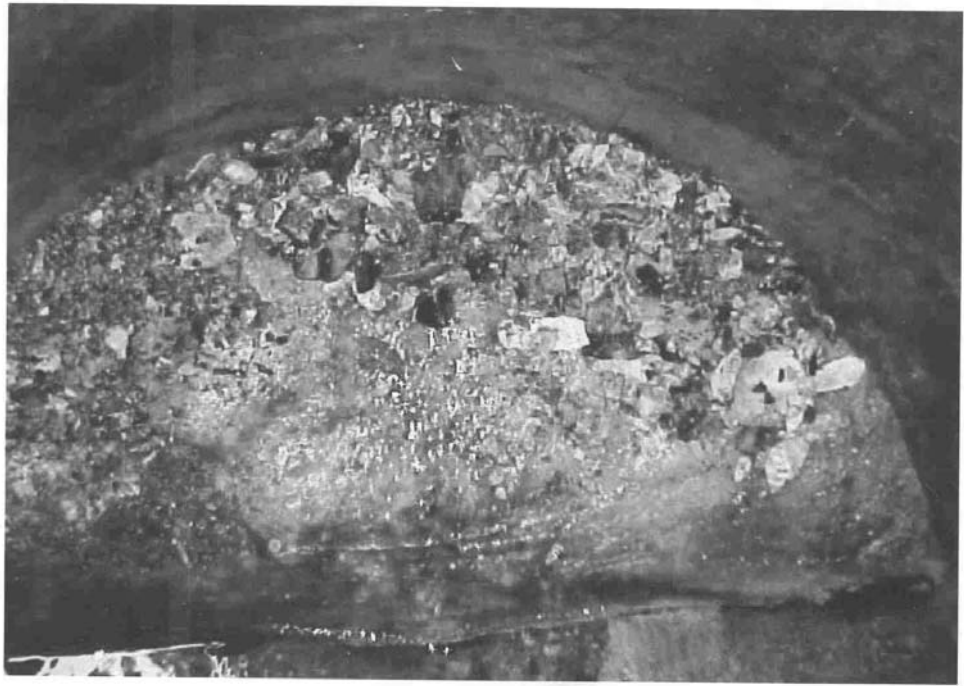
C3
C3
C3

TV inspection of the sewers showed that the scale was present only above the sewage level and it was heaviest at, and close to, the manholes.

- (iii). When the groundwater level rises during the wet season, the groundwater infiltrates the sewer and manholes where it encounters an oxygenated (aerobic), lower carbon dioxide-content atmosphere. The infiltrated groundwater pH increases. This causes precipitation of calcium carbonate (the whitish scale).

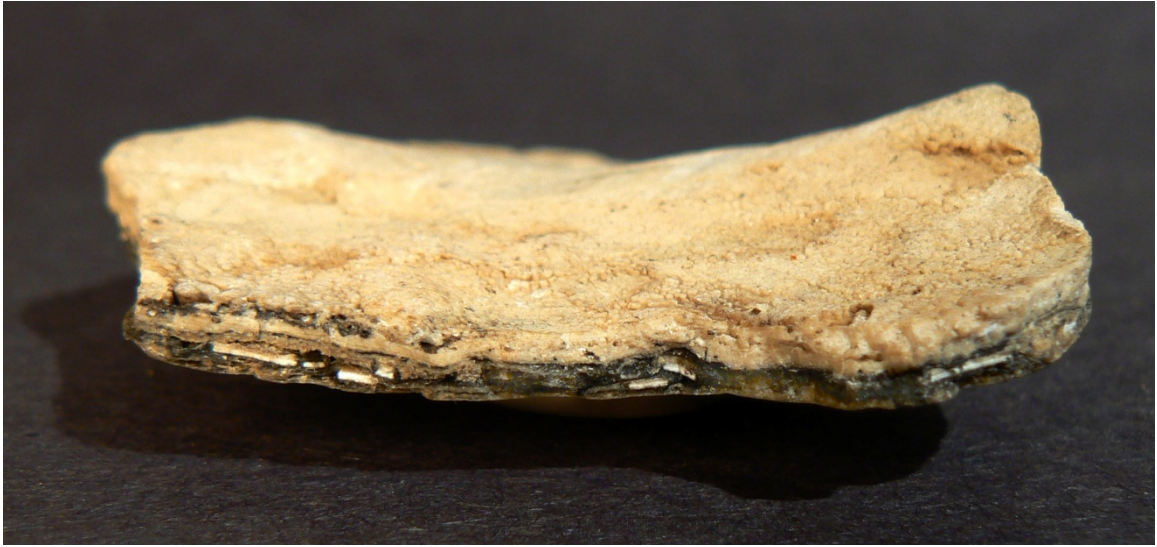
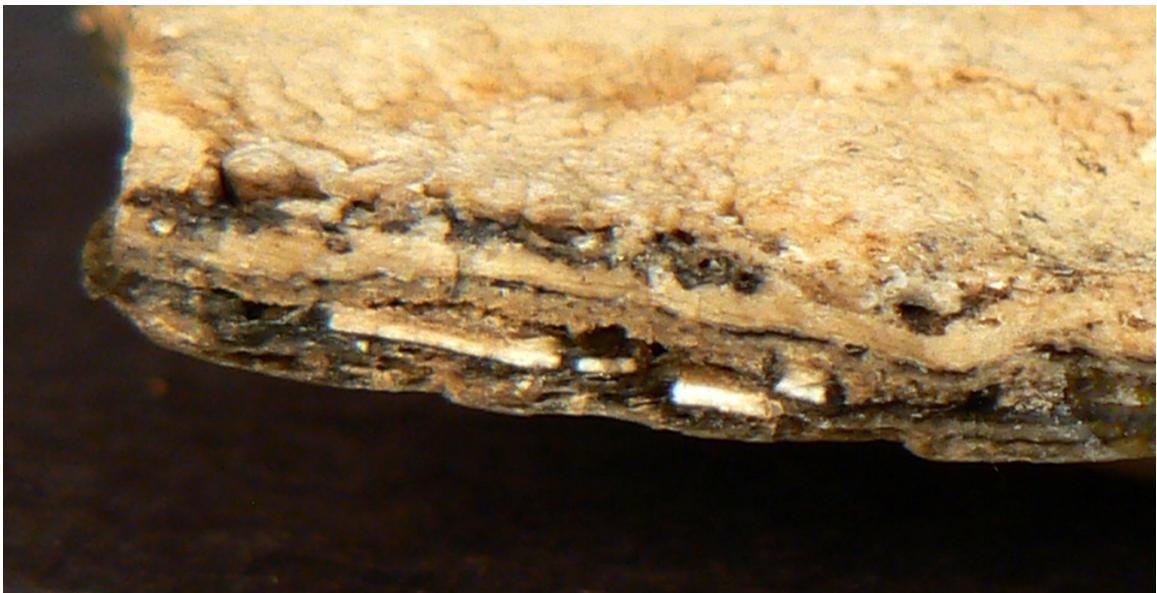
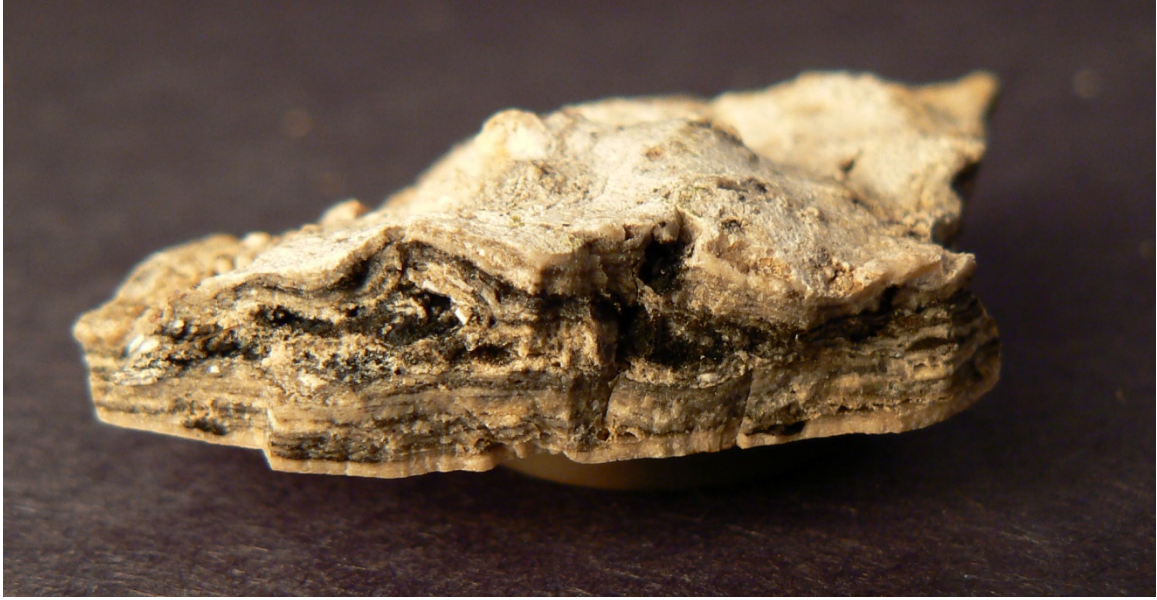
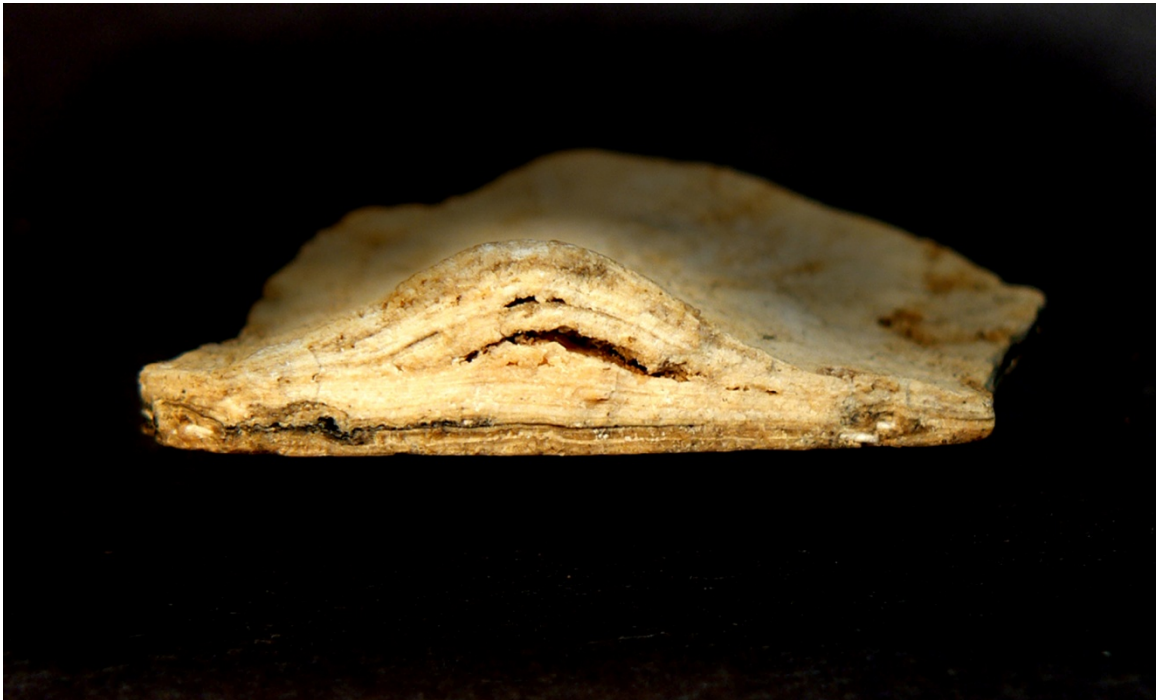
Photographs of Scale Showing its Banded Structure

Closer visual examination of the scale samples revealed that they had a banded structure with whitish (major) and black (minor) layers (Appendix 3). Material was removed from each layer of the scale by scraping the individual layers with a scalpel and a knife point. An intact scale sample and the powdered materials scraped from each layer were sent to R.J. Lee Group (Lee) for analysis by scanning electron microscopy with energy dispersive spectroscopy (SEM/EDS) and by X-ray diffraction (XRD). SEM/EDS analysis provides information on the overall morphology and the elemental composition of solids (Appendix 4). XRD analysis yields information on the crystalline nature of solids (Appendix 4).

(iii). The scale has a banded structure consisting of alternating layers of whitish calcium carbonate and a black manganic oxide mineral.

The banded structure of the scale is explained by the seasonal variation of the groundwater level. Successive layers of scale are laid down as the groundwater rises and falls during the wet (high groundwater) and dry (low groundwater) seasons. The whitish calcium carbonate precipitates first because its precipitation relies solely on the pH change encountered when the groundwater is exposed to the lower carbon dioxide content of the sewer atmosphere. The manganic oxide precipitation occurs later because it requires the development of a microbial community capable of oxidizing the manganous salts in the infiltrated ground water to manganic salts.
